Residual Ridge Under Long Standing Bridge

Series A, Number 5

JOHN LUPOVICI, DDS. *New York, New York*

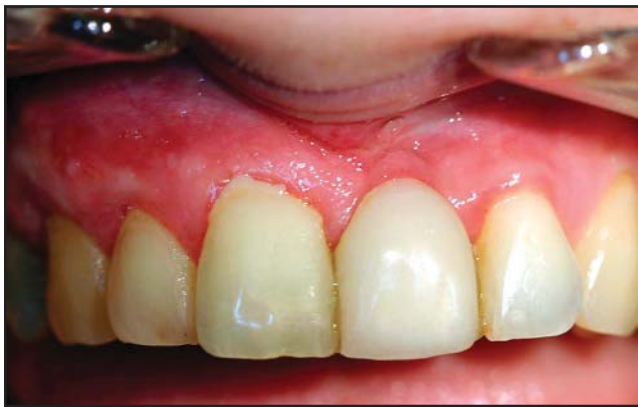
FIG. 1: Pre-treatment view of existing restoration.

A 47-year-old patient presented with a request for implant placement in the site of #9, long standing Maryland Bridge. The site was lacking ridge width to support implant placement.

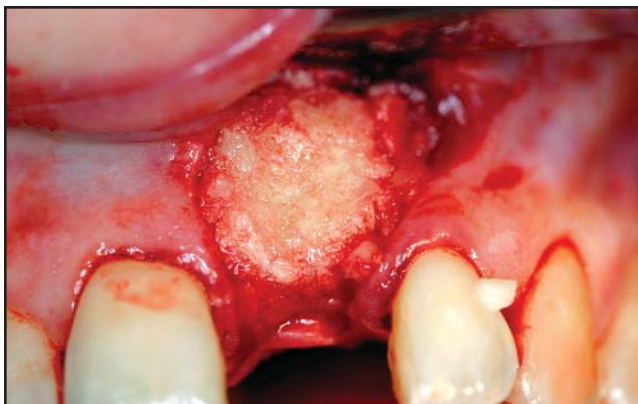
FIG. 3: Placement of 0.5cc Regenaform® in prepared graft site. The area was lightly decorticated and cleaned of all tissue tags and remnants prior to placement.

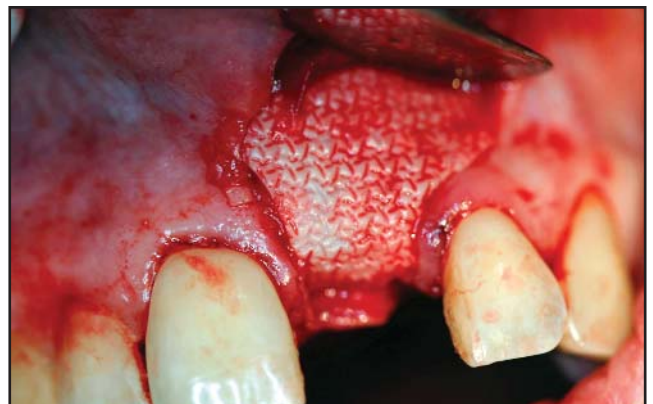
FIG. 4: Ossix® collagen membrane placement

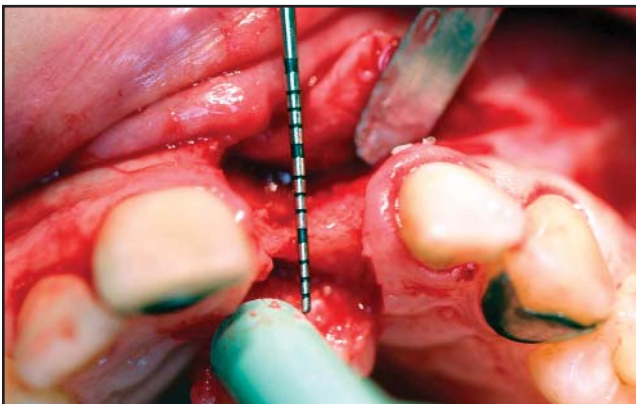
FIG. 9: Pre-op.
