Regeneration Of A Facial Defect Following Tooth Extraction In the Aesthetic Zone: A Case Presentation

Clinical Treatment By John Lupovici, DDS (USA)†

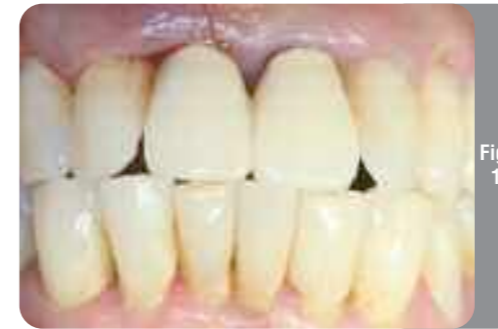
Fig. 1

A 62-year-old female patient presented with hopeless dentition in the maxillary anterior region secondary to advanced periodontal involvement (Figure 1). Radiographic examination revealed advanced localized horizontal and vertical involvement (Figure 2). The patient's chief complaint was progressive migration of the maxillary anterior dentition. Due to advanced and severe loss of supporting alveolus and high aesthetic requirements of treating the maxillary anterior region, the treatment plan included a staged approach to tooth extraction and regeneration to provide an optimal restorative result, followed by implant placement in five months.

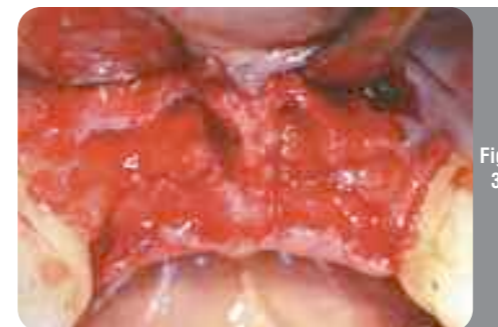
Fig. 3

A full thickness mucoperiosteal flap was elevated facially from cuspid to cuspid to expose the defect (Figure 3). The large facial defect was carefully debrided and grafted with RegenerOss™ Allograft Putty in conjunction with Endobon® Xenograft Granules, a RegenerOss Product (Figure 4). This combination of materials was chosen to optimize the strengths of the individual graft materials. The RegenerOss Allograft Putty was selected for its verified osteoinductive properties as well as for its superior handling in heme filled sites. Endobon Xenograft Granules were selected due to well-documented osteoconductive properties and a long resorption profile.

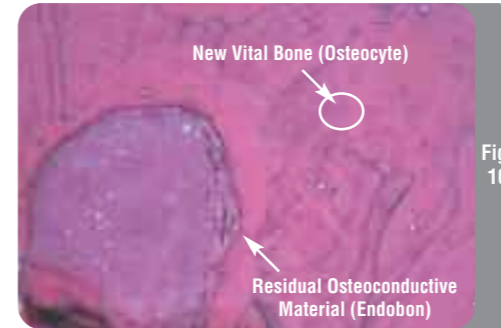
Fig. 10

Histology: The core was sent for histologic evaluation, which revealed vital bone cells in conjunction with evidence of the incorporation of the Endobon Xenograft Granules (Figure 10). No foreign body reaction was noted.
